A & R DEPARTMENT NARRATIVE CODE SHEET

NASC:113:dj
Ser: 965
25 April 1963

Subj: VX-5 AAR ser 1-62 concerning A-4C (A4D-2N) BuNo 145066 accident
occurring 25 September 1962, pilot (b) (6)

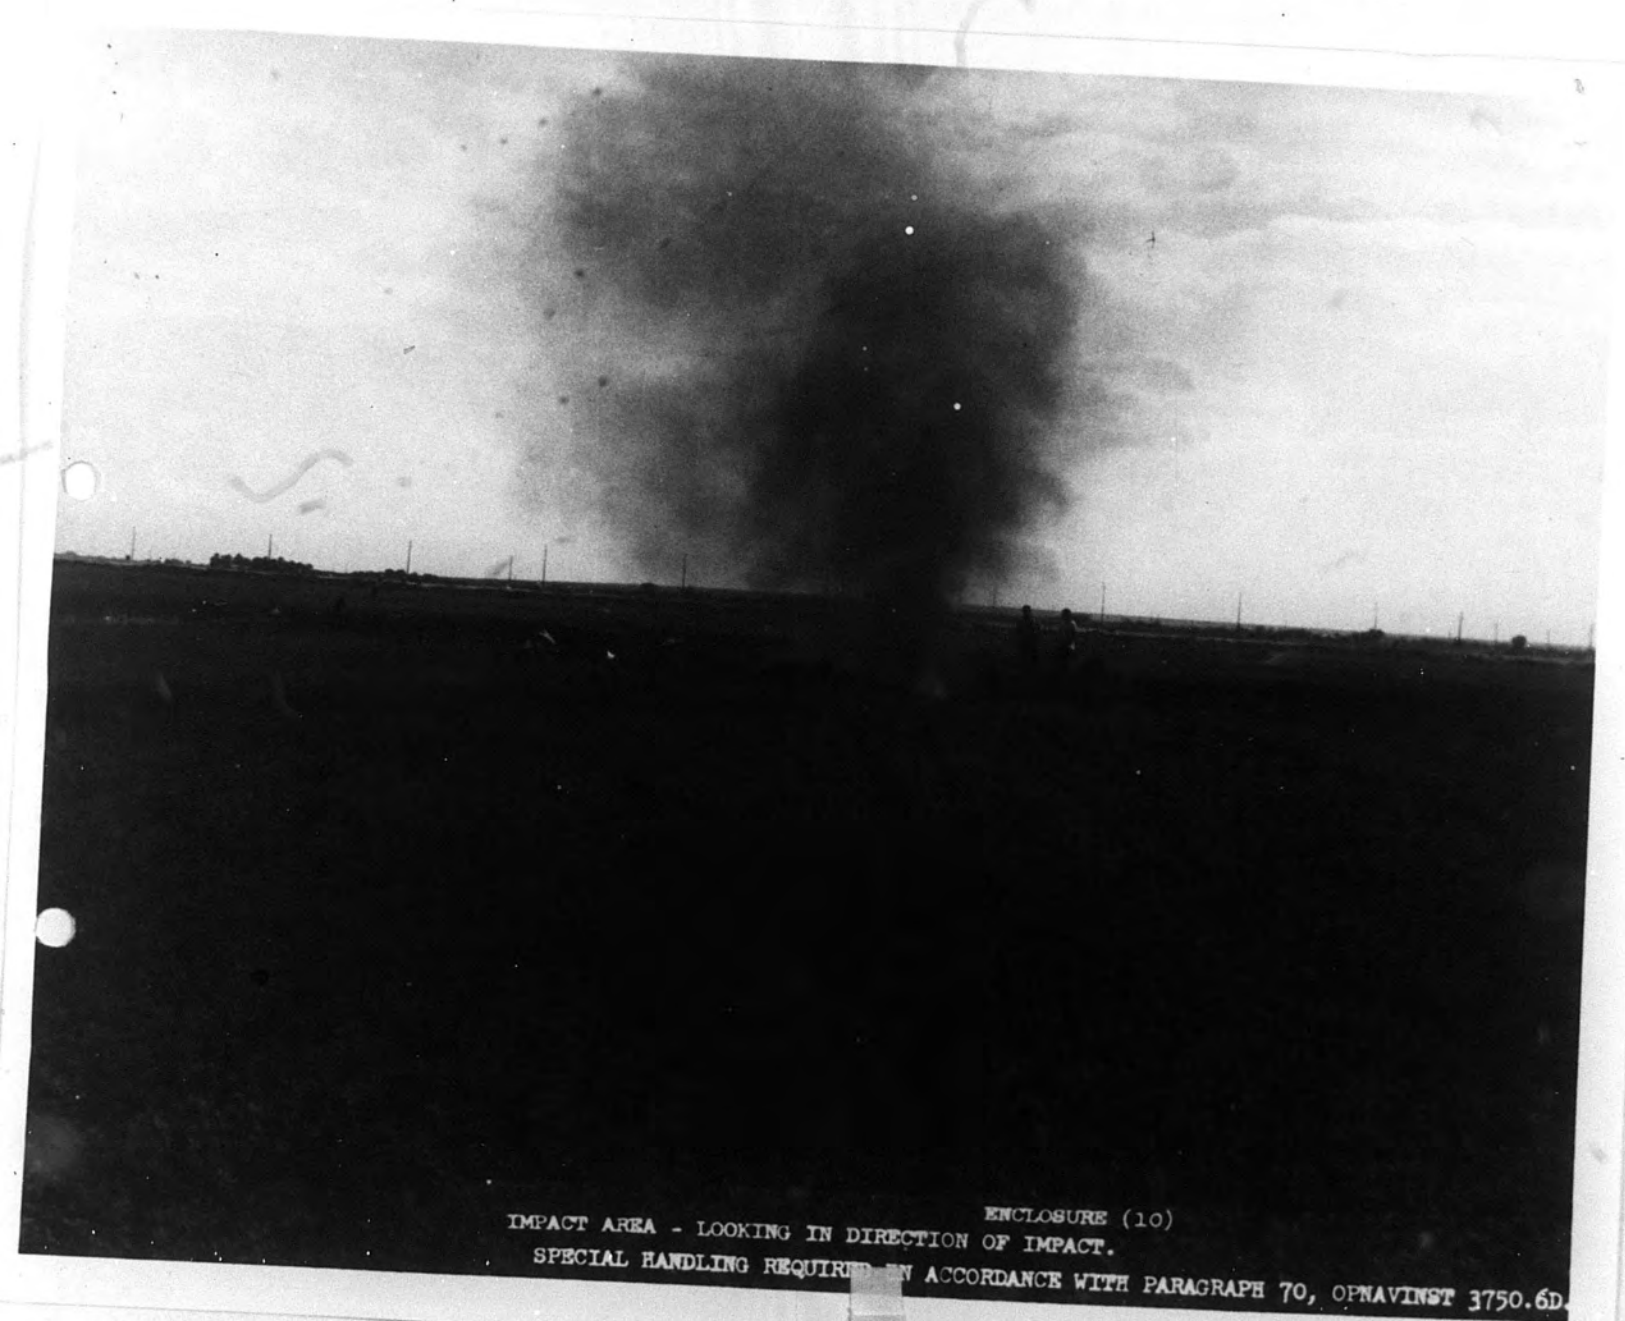
ENCLOSURE (10)
IMPACT AREA - LOOKING IN DIRECTION OF IMPACT.

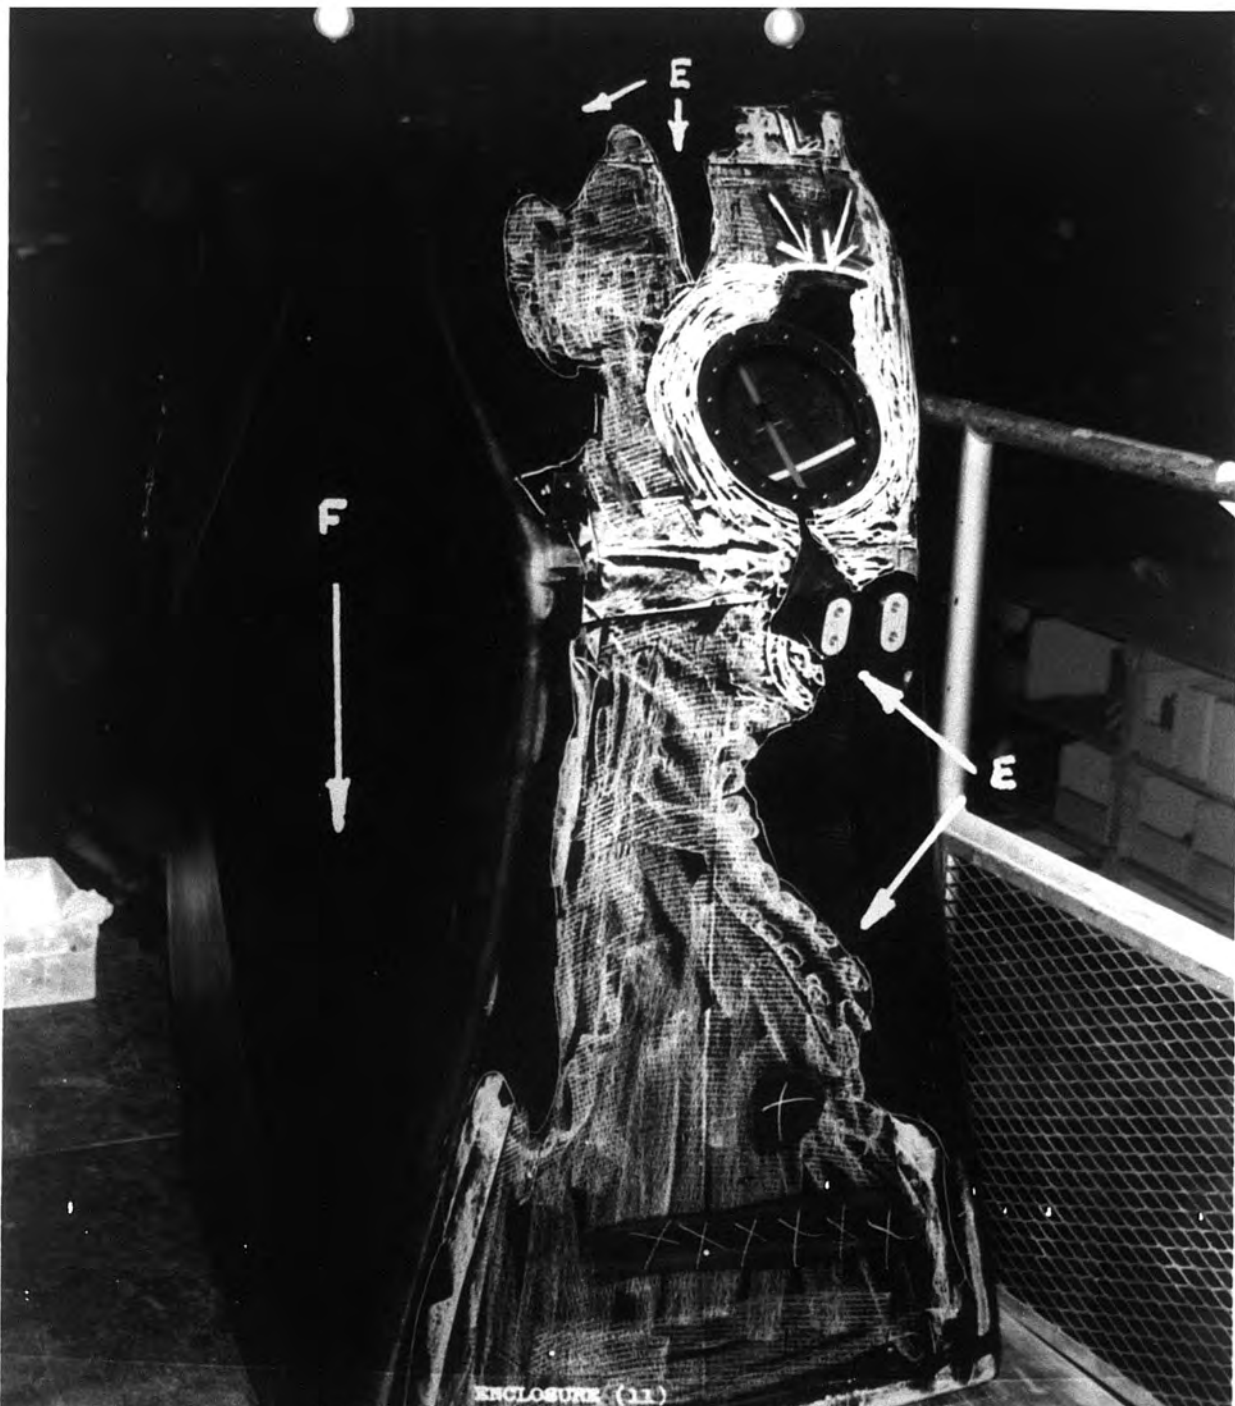
ENCLOSURE (11)

BOTTOM OF FUEL CELL. (a) CHALKED AREA SHOWS RECOVERED PIECES OF CELL. (b) SINGLE "X" SHOWS ONE ACTIVATED AREA. (c) MULTI "X" SHOWS AREA BOTH SEPARATED AND ACTIVATED. (d) ARROWS SHOW ACTIVATED AND DEFORMED AREA. (e) ACTIVATED AREA (f) FORWARD

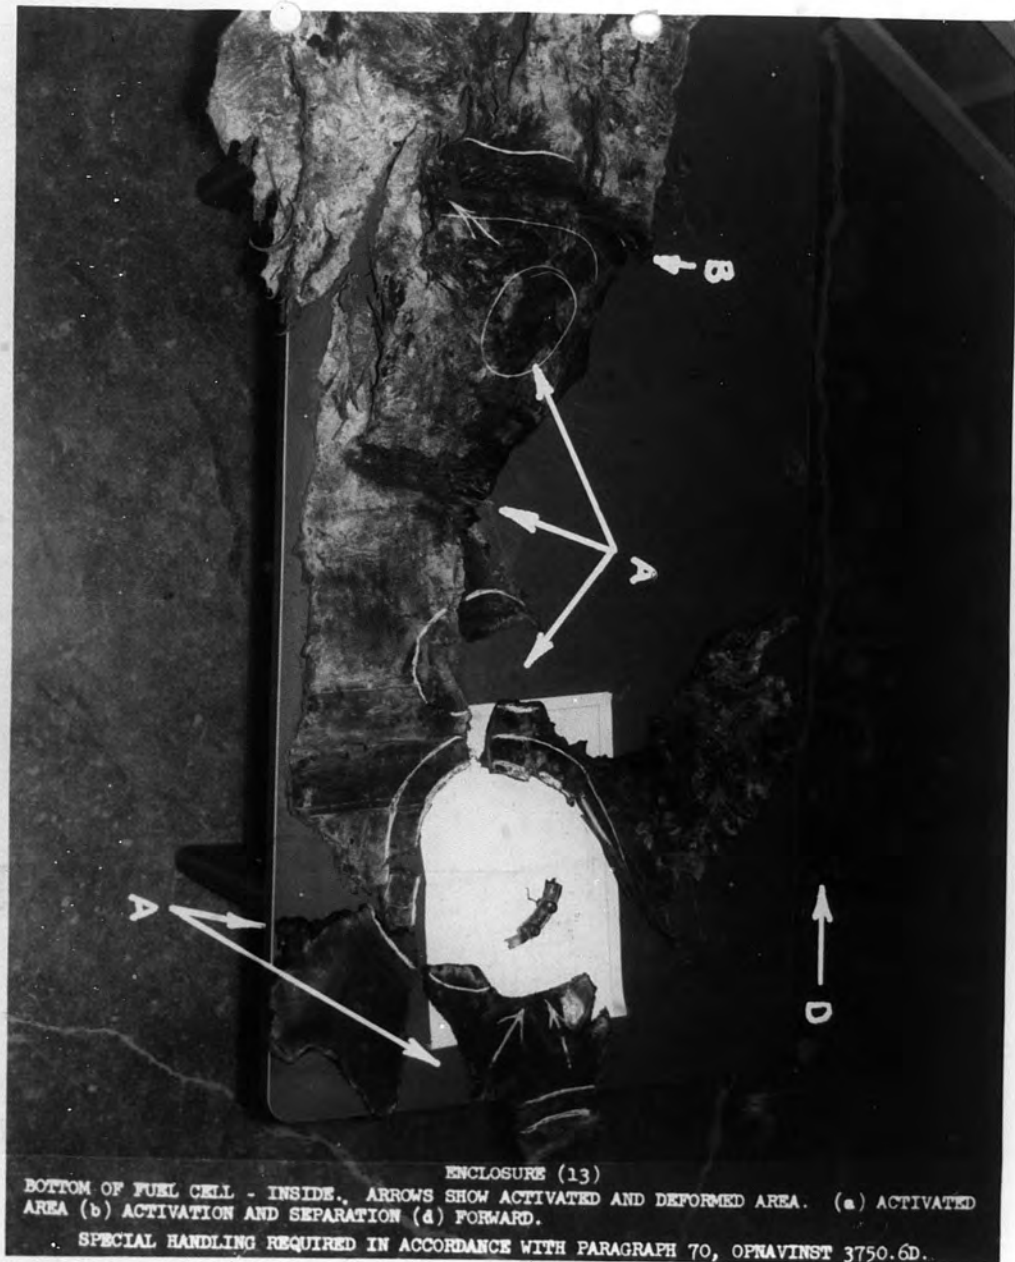
ENCLOSURE (13)

Examination of the bottom of the cell revealed several areas of activation, one large area of tank separation and one area of deformation. (see enclosures (12-17)). From pieces of the fuel cell it was determined that only the activated (fuel soaked) areas had burned. Enclosures (12&13) clearly shows that the fuel cell did not burn beyond the activated area.

BOTTOM OF FUEL CELL - INSIDE. ARROWS SHOW ACTIVATED AND DEFORMED AREA. (a) ACTIVATED AREA (b) ACTIVATION AND SEPARATION (d) FORWARD.

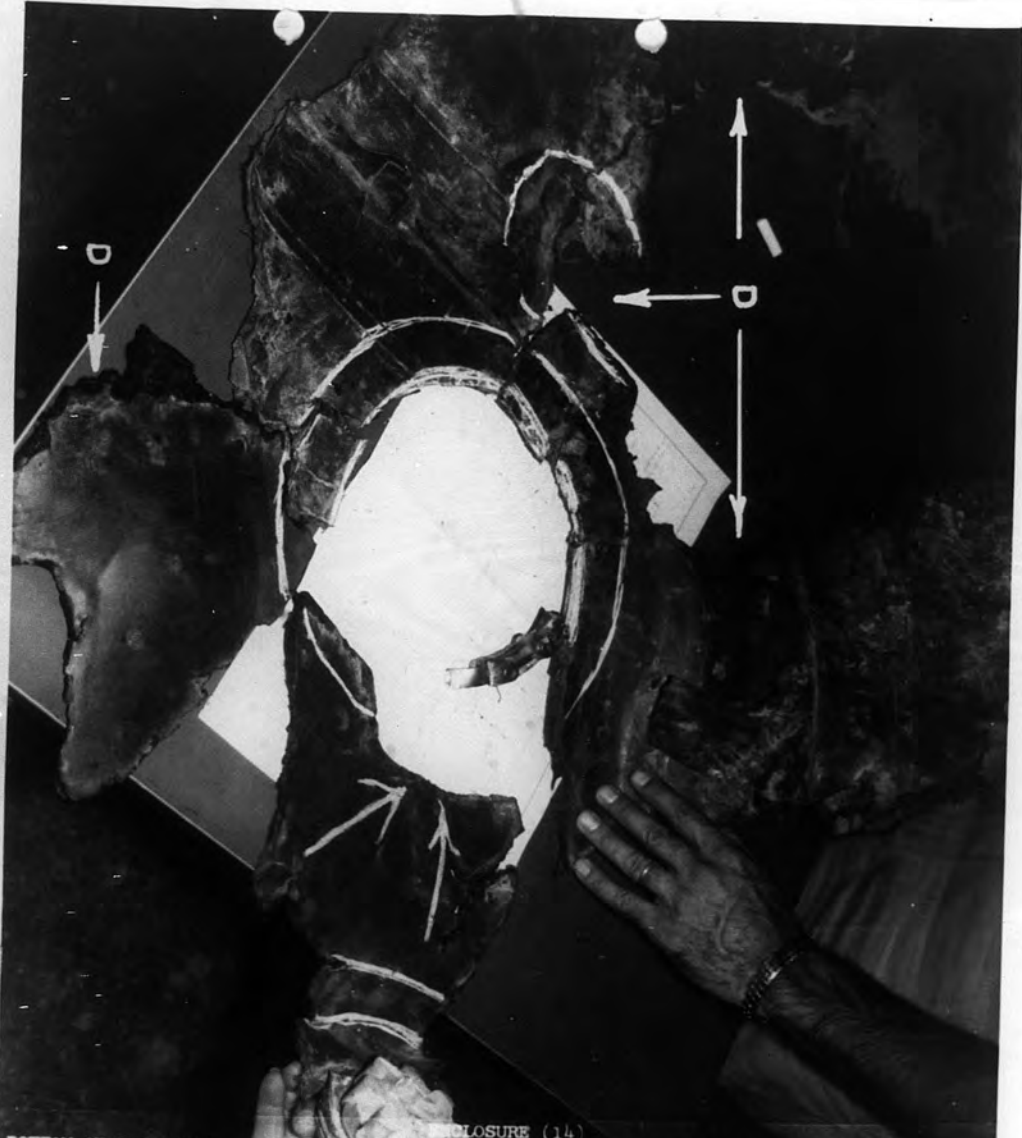
The most probable cause of this accident was a failure or rupture of that portion of the bottom of the fuselage fuel cell containing the fuel boost pump. Initial rupture of the tank caused the overboard fuel flow noticed by the wingman. Further failure of the fuel cell caused by the velocity of the escaping fuel caused the collapse of the main cell sump bulkhead supported only by the five (5) nylon stiffeners. The center portion of this bulkhead draped over the fuel boost pump resulting in closing of the two center flappers. The four outer flappers were closed by contact with the outer walls of the main fuel cell. The engine flamed out when the sump compartment emptied of fuel. The indicated 1000 pounds of fuel reflected only the quantity remaining in the fuselage cell which had been trapped when the sump bulkhead collapsed.

ENCLOSURE (14)
 BOTTOM OF FUEL CELL - INSIDE. SLICE UP OF FUEL BOOST PUMP AREA. (a) ARROWS SHOW AREA
 OF ACTIVATION AND DEFORMATION. (b) OUTLINED AREA OF CELL LAYED OVER BLUEPRINT SHOWS
 BOOST PUMP FLANGE AREA. (c) OUTLINED AREA AT TOP OF PICTURE SHOWS CELL MOUNTING AREA
 (d) ACTIVATED AREA.

It is recommended that all A4D fuselage fuel cells be removed at every PAR period and be thoroughly inspected. It is further recommended that consideration be given to increasing the width of the fuel boost pump bracket (Part No. 3665809) for increased support for the fuel cell in this area.

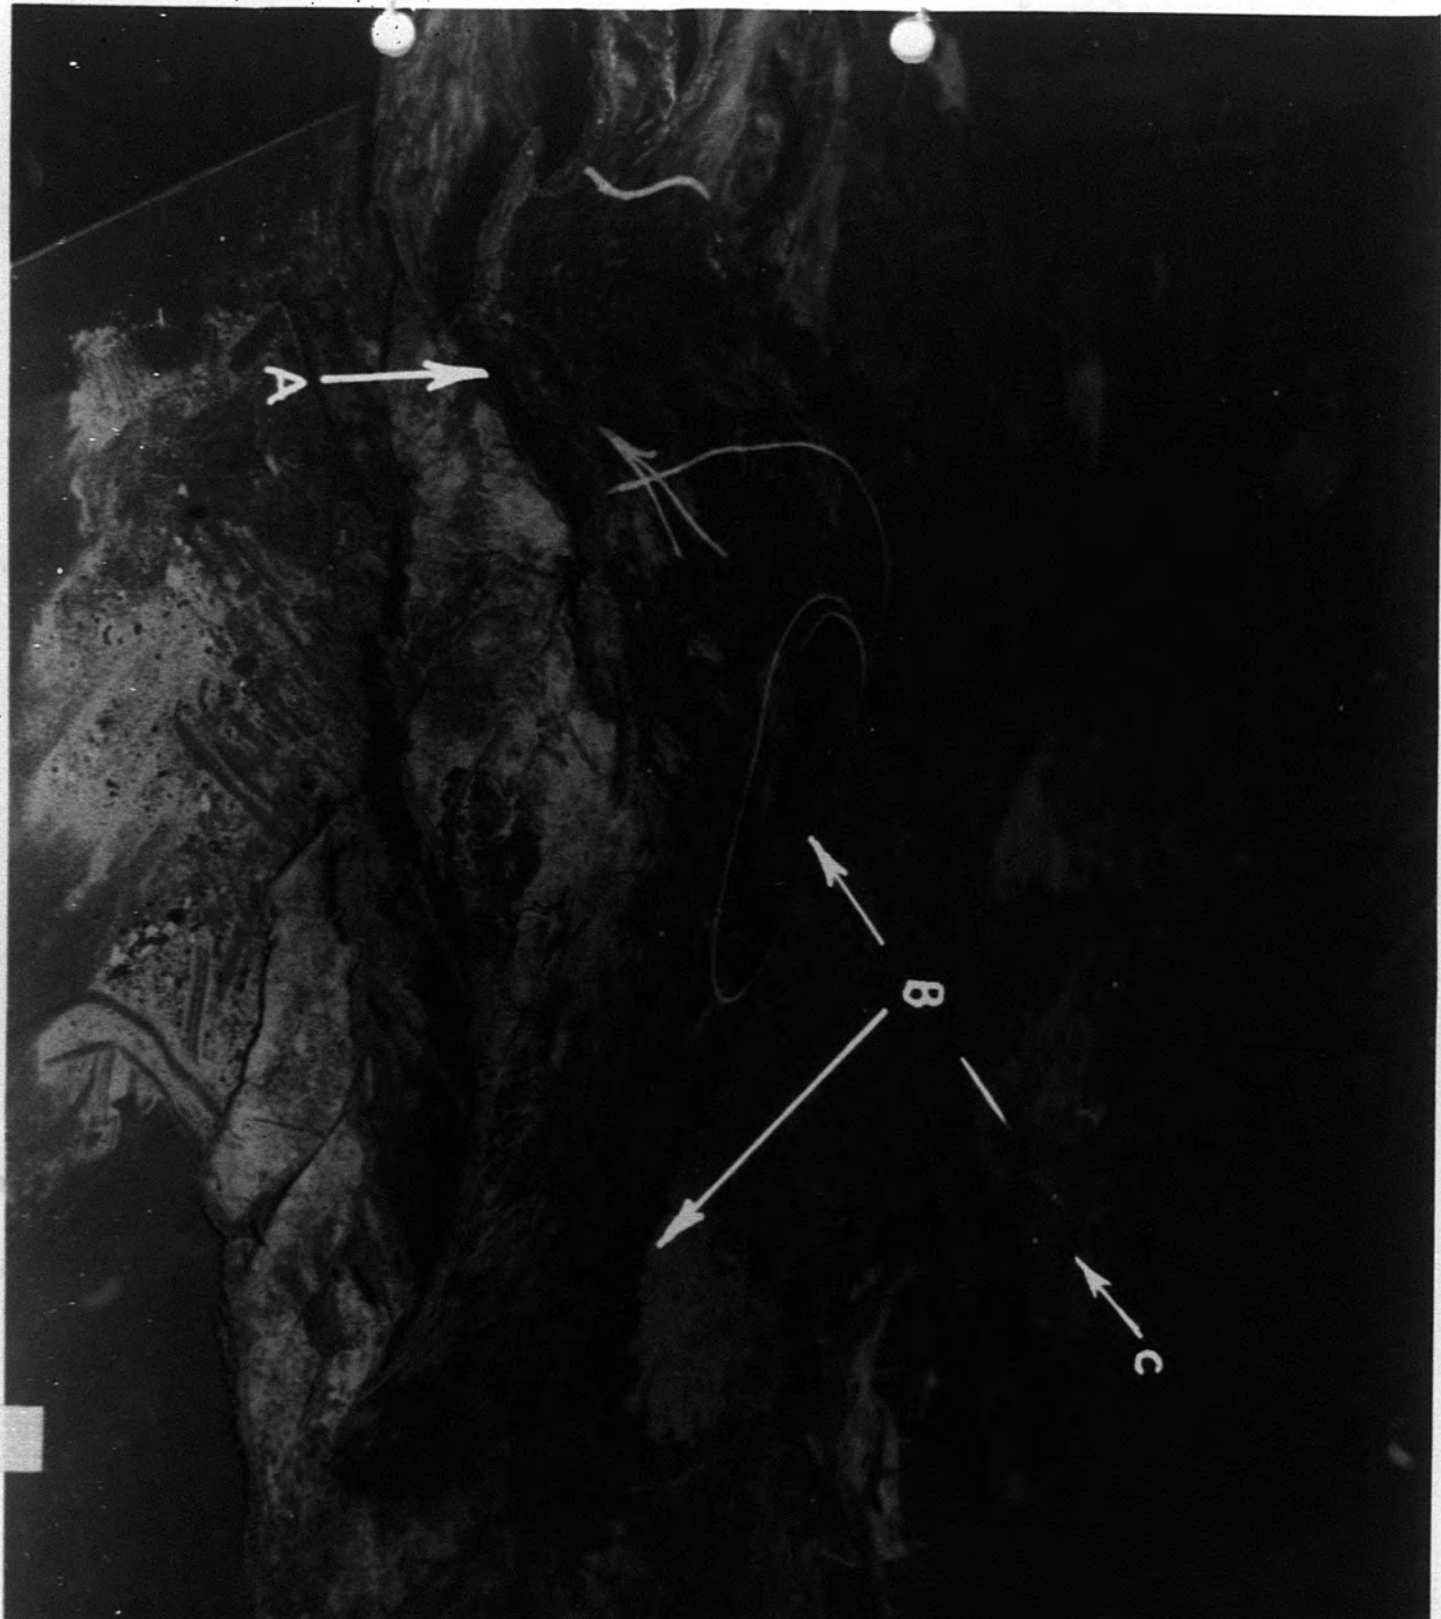
ENCLOSURE (15)

An activated area is that portion of the fuel tank which has had the self sealant section of the tank activated by the airplane fuel. Only the inside of the tank has a fuel proof layer of material; thus, for activation to start from the inside, this fuel-proof layer must be damaged/broken by some method. Because the outside layer does not have a fuel proof layer, fuel can penetrate the outer portion of the tank and activate the self sealant, thus causing a raised portion (ply separation) on the inside of the cell (see enclosure (15)).

BOTTOM OF FUEL CELL - FORWARD OF BOOST PUMP AREA. A. ACTIVATION AND SEPARATION.
B. ACTIVATION C. FORWARD

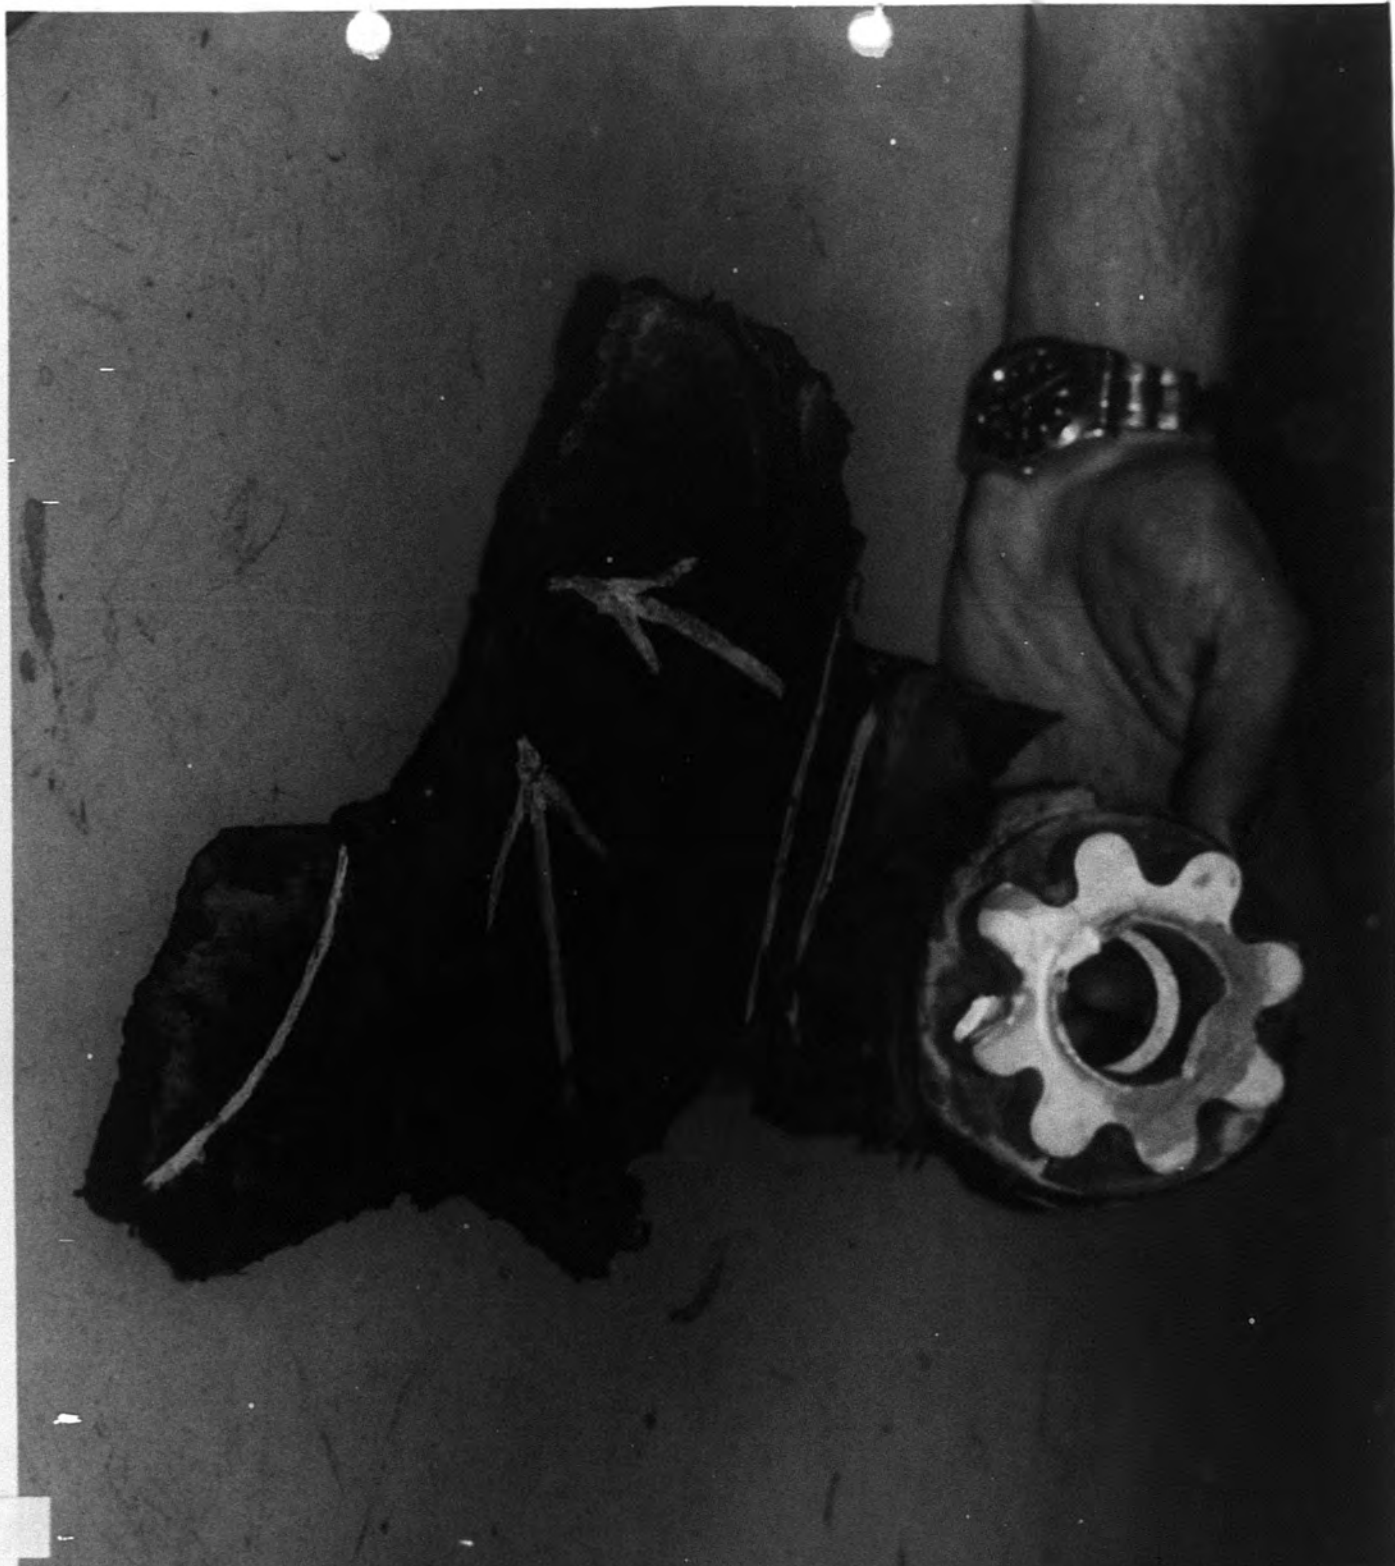
ENCLOSURE (16)

DEFORMATION OF FUEL CELL (INSIDE) JUST AFT OF THE BOOST PUMP. ARROWS SHOW ACTIVATED AND DEFORMED AREA

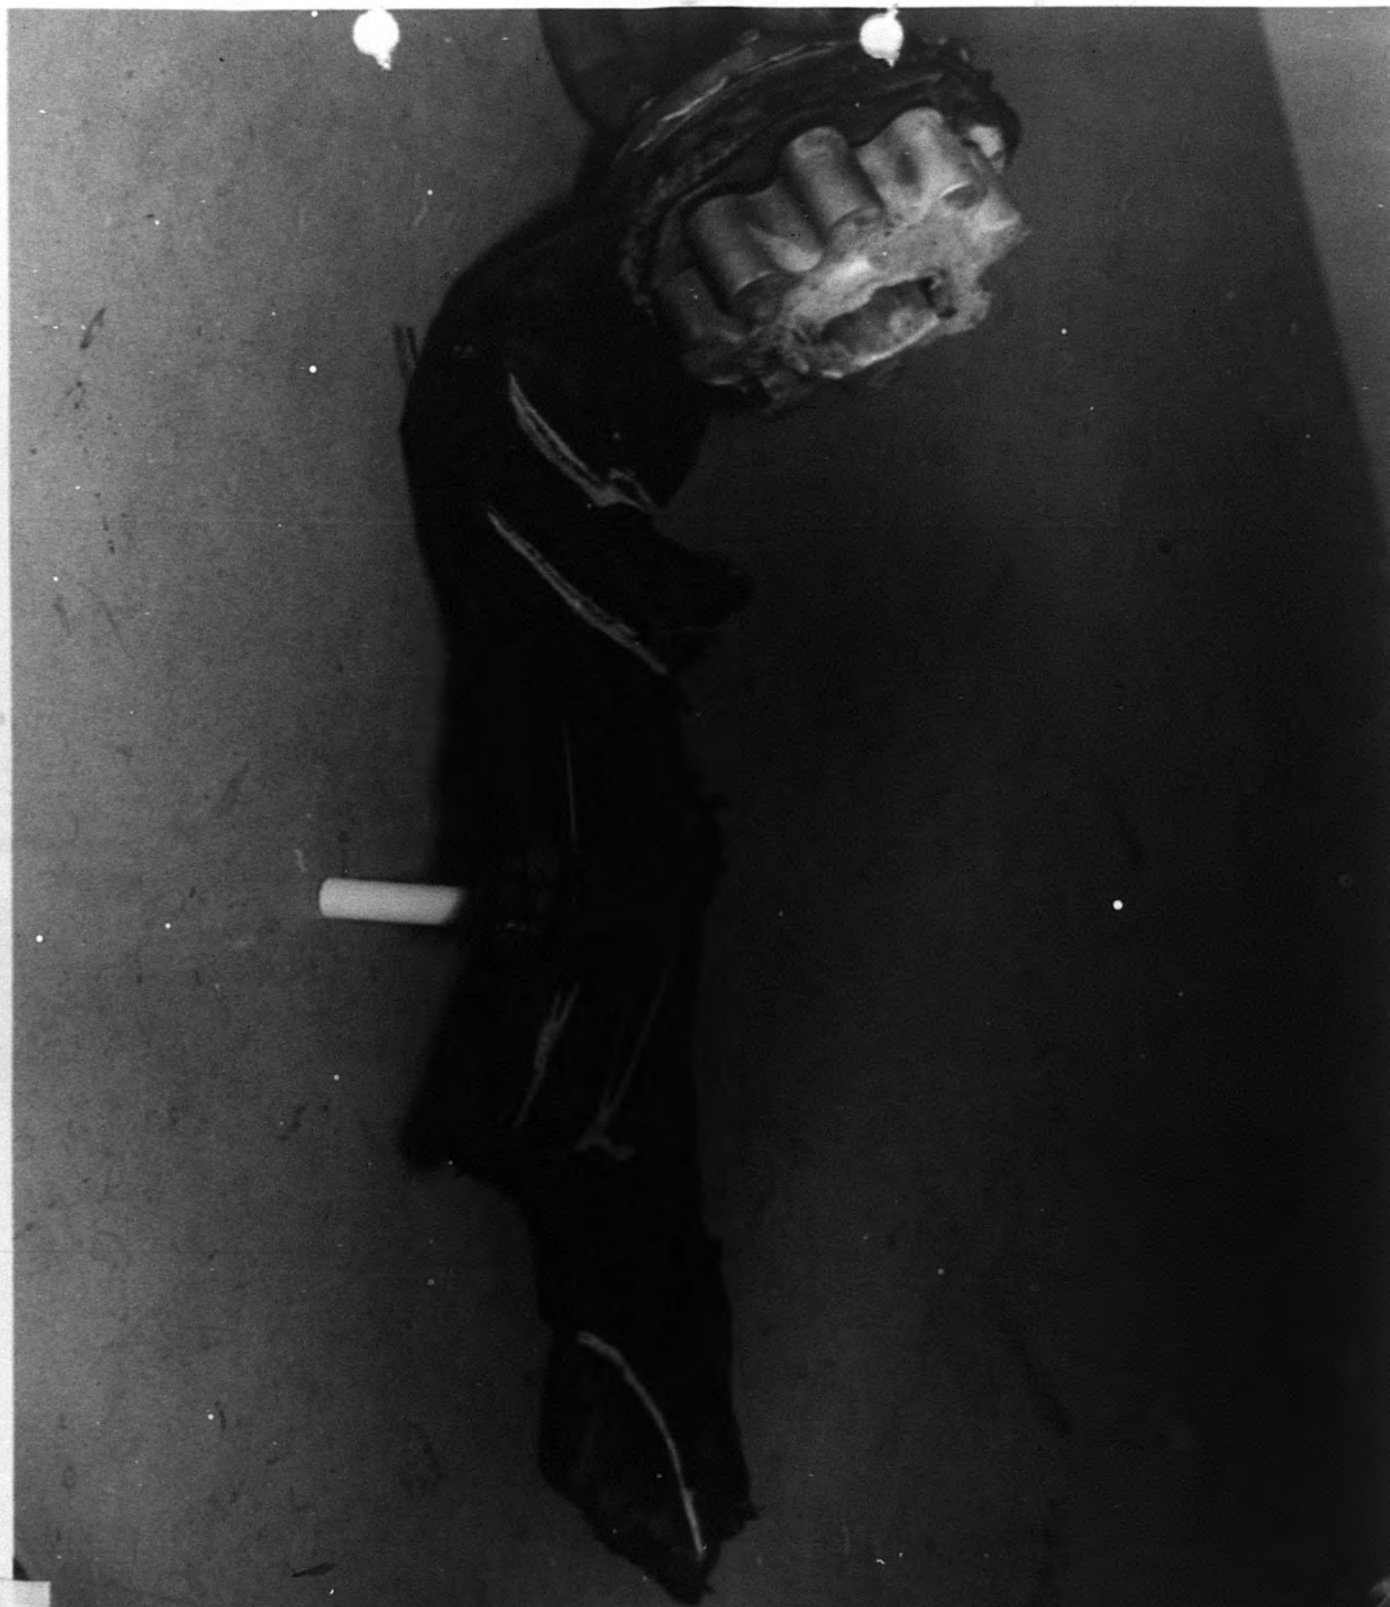
ENCLOSURE (17)

DEFORMATION OF FUEL CELL JUST AFT OF BOOST PUMP. ARROWS SHOW ACTIVATED AND DEFORMED AREA
SPECIAL HANDLING REQUIRED IN ACCORDANCE WITH PARAGRAPH 70, OPNAVINST 3750.6D.
